**Flood Control Project Maintenance
Levee Inspections**
LMA District Cover Sheet
Spring 2018 Levee Inspection Results

Reclamation District No. 0563 Tyler Island

Spring 2018 Levee Inspection Results

Waterway			Bank	Unit Miles
Unit No. 01 Georgiana Slough (Tyler Island)			Left	12.11
	Spring (March - May)	Summer (June - August)	(September - November) Fall	Winter (December - February)
Unit Maintenance Rating (Fall Only)				
Date of Inspection	3/30/2018 - 3/30/2018			
DWR Inspector	Keith Millard			
Accompanied By	Steve Mello RD 563

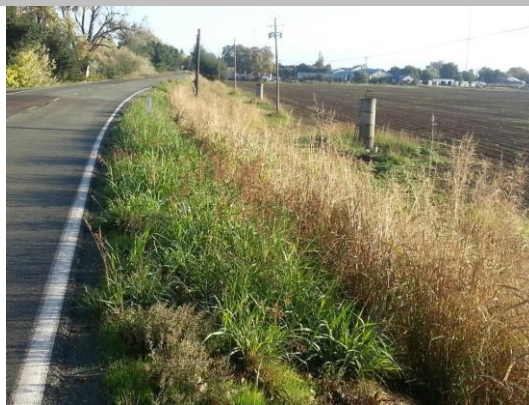
Photo 2 of 2 : SP_2018_RD0563_210_138_20180305_00115.jpg

LM Start	0.15	Rating **	M	Issue No.	138
LM End	0.66	Issue Type +	Ma	Location *	LS
Category	Earthen Levee			GPS Latitude/Longitude	
				Start	End
Item	Vegetation			38.233572 °	38.228100 °
				-121.519080 °	-121.525225 °
DWR ID	DWR_RD0563_01_f_2015_138				
Comment Code					
V2 : Remove the wild growth other than native grasses from the levee slopes.					
Inspector Comment					
Dense vegetation on landside slope.

Looking east at dense veg on landward slope.

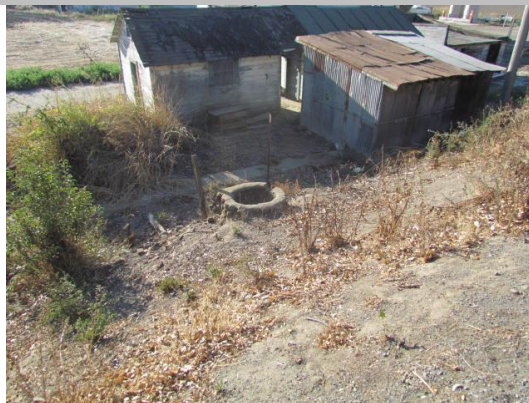
Photo 1 of 3 : SP_2018_RD0563_210_10_20180305_00007.jpg

LM Start	0.15	Rating **	M	Issue No.	10
LM End	0.15	Issue Type +	En	Location *	LS
Category	Earthen Levee			GPS Latitude/Longitude	
				Start	End
Item	Encroachments			38.233572 °	38.233572 °
				-121.519083 °	-121.519083 °
DWR ID	DWR_RD0563_01_f_2013_10				
Comment Code					
BU : Building					
Inspector Comment					
Tool shed and fire pit on landward slope and toe.

Looking east at fire pit on landward slope.

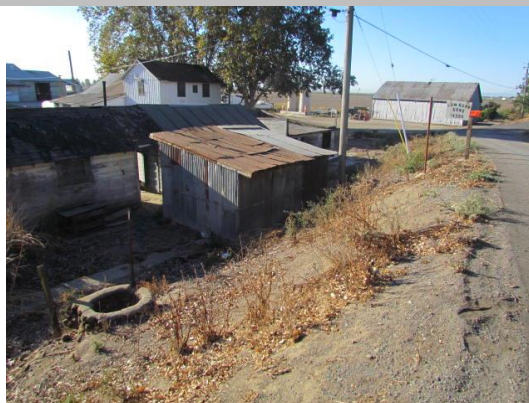
Photo 3 of 3 : SP_2018_RD0563_210_10_20180305_00009.jpg

LM Start	0.15	Rating **	M	Issue No.	10 (cont)	
LM End	0.15	Issue Type +	En	Location *	LS	
Category	Earthen Levee			GPS Latitude/Longitude		
				Start		End
Item	Encroachments			38.233572 °		38.233572 °
				-121.519083 °		-121.519083 °
DWR ID	DWR_RD0563_01_f_2013_10					
Comment Code						
BU : Building						
Inspector Comment						
Tool shed and fire pit on landward slope and toe.

Looking southeast at storage shed at landward toe.

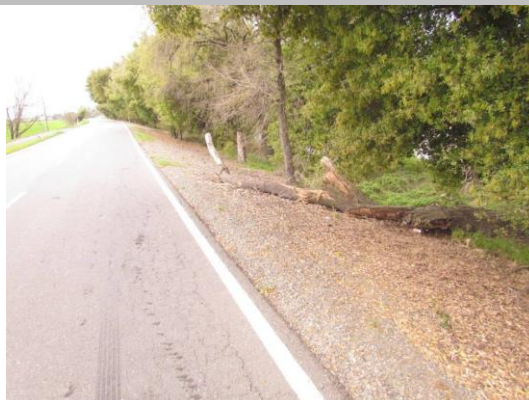
Photo 1 of 2 : SP_2018_RD0563_210_32_20180305_00023.jpg

LM Start	0.17	Rating **	M	Issue No.	32
LM End	0.17	Issue Type +	Ma	Location *	WS
Category	Earthen Levee			GPS Latitude/Longitude	
				Start	End
Item	Encroachments			38.233315 °	38.233315 °
				-121.519360 °	-121.519360 °
DWR ID	DWR_RD0563_01_s_2012_32				
Comment Code					
TR : Tree or limb					
Inspector Comment					
Tree fallen across waterward slope.

Looking downstream at tree branch on waterward slope. (Spring 2017)

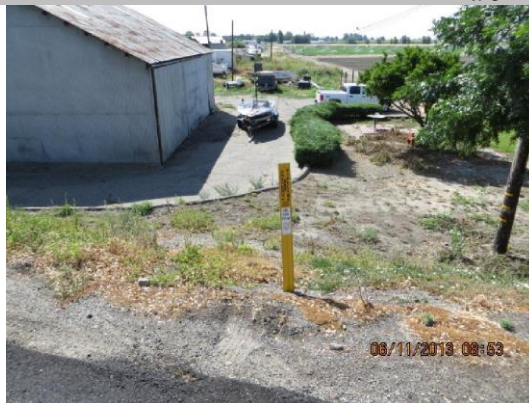
Photo 1 of 2 : UCIP_SP_2018_14865_24505.jpg

LM Start	0.20	Rating **	M	Issue No.	772
LM End	0.20	Issue Type +	En	Location *	
Category	Supplemental			GPS Latitude/Longitude	
				Start	End
Item	DWR UCIP Field Study			38.233027 °	38.233027 °
				-121.519631 °	-121.519631 °
DWR ID					
Comment Code					
Inspector Comment					
FS_ID:14865 DS_ID:20129 EP_NO: 3448 Repair Type: Non-Urgent Crossing Status: Indicator Found UCIP Comments: Sign on waterside slope should be cleared of vegetation. FIELD_STRUCT_DESC: 4.5-inch steel gas line through the levee, 4 feet below the crown and across the channel. Large warning sign on the waterside (WS) slope. (Permit No. 3448, 1960 - Pacific Gas and Electric Company [PG&E]). [Additional Reference(s): DWR Levee Log, 2005]. FS Date: 6/11/2013

Gasline marker on LS shoulder.

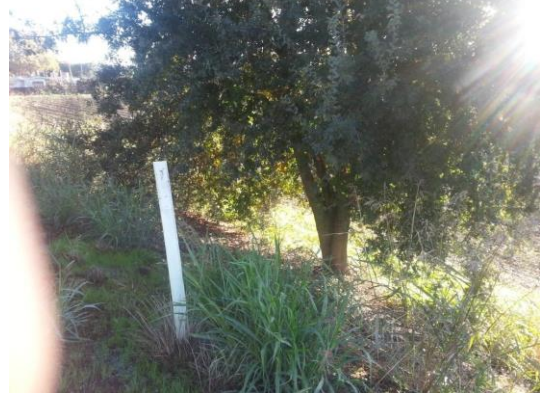
Photo 1 of 1 : SP_2018_RD0563_210_168_20180305_00131.jpg

LM Start	0.29	Rating **	M	Issue No.	168
LM End	0.29	Issue Type +	Ma	Location *	LS
Category	Earthen Levee			GPS Latitude/Longitude	
				Start	End
Item	Trim / Thin Trees			38.231955 °	38.231955 °
				-121.520728 °	-121.520728 °
DWR ID	DWR_RD0563_01_f_2016_168				
Comment Code					
T2 : Thin trees to allow visibility of the ground and room to flood fight.					
Inspector Comment

Looking east at untrimmed tree on landward slope.

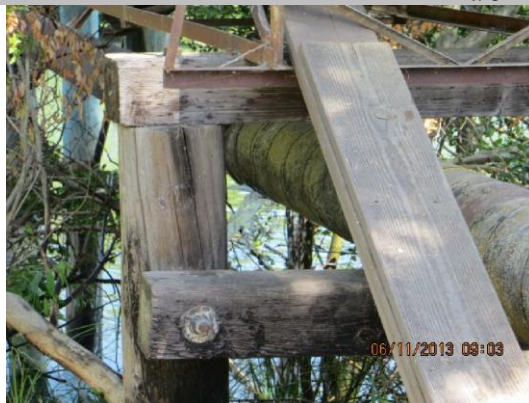
Photo 3 of 3 : UCIP_SP_2018_14866_24506.jpg

Comment Code						
Inspector Comment						
FS_ID:14866 DS_ID:20130 EP_NO: 11218 Repair Type: Non-Urgent Crossing Status: Found UCIP Comments: Pipe leaking at various points on WS berm. Failure on berm may indicate potential for failure within the levee. Good candidate for video inspection. FIELD_STRUCT_DESC: 12-inch steel irrigation pipe through the levee, 5 feet below the crown. Walkway to pump on pile structure in stream. Siphon breaker in a 24-inch corrugated metal pipe (CMP) riser on the waterside (WS) shoulder. 1-inch air and vacuum valve and a 15-foot-tall by 36-inch-diameter concrete standpipe at the landside (LS) toe. (Automatic Board Order (ABO) issued as Permit No. 11218, 1975 - Fong Yock Yee). [Additional Reference(s): DWR Levee Log, 2005. USACE Sacramento O&M Manual 103, June 1954, (Station ""L2"" 196+67.8)]. FS Date: 6/11/2013

Leak in pipe on WS berm.

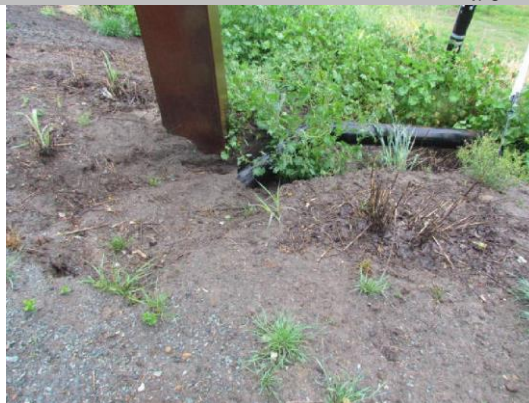
Photo 1 of 1 : UCIP_SP_2018_51627_76994.jpg

LM Start	0.72	Rating **	M	Issue No.	774
LM End	0.72	Issue Type +	En	Location *	
Category	Supplemental			GPS Latitude/Longitude	
				Start	End
Item	DWR UCIP Field Study			38.227328 °	38.227328 °
				-121.525872 °	-121.525872 °
DWR ID					
Comment Code					
Inspector Comment					
FS_ID:51627 DS_ID:25486 EP_NO: N/A Repair Type: Non-Urgent Crossing Status: Found UCIP Comments: 04/20/2017 Slight depression above pipe near landside shoulder as per DWR inspector Richard Willoughby, as noted during his Spring 2017 inspection. (K. Fazel - UCIP) FIELD_STRUCT_DESC: 6-inch externally-coated steel irrigation pipe, 3 or 4 feet below the crown. Pipe is likely a replacement for the 12-inch at this location under DSID 20131. Pipe is not permitted and found by DWR inspector Richard Willoughby during Spring 2017 inspection. FS Date: 4/20/2017

View of newly installed steel pipe and depression above it. Photo courtesy of Richard Willoughby.

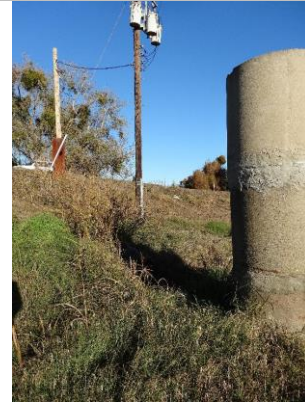
Photo 1 of 3 : UCIP_SP_2018_52608_76821.jpg

FS_ID:52608
DS_ID:20131
EP_NO: 11203
Repair Type: Urgent
Crossing Status: Found
UCIP Comments: 03/08/2018 LS pipe section replaced however, unable to determine the condition of the pipe section through the levee. LS levee section disturbed and has not been repaired. Crossing remains Urgent due to the unknown condition of the pipe section through the levee. (O. Magana - DWR UCIP)12/02/2016 Same as last inspection signs of leak are still present on both LS and WS. Recommend internal inspection of the pipe integrity though the levee to determine cause of depression on levee (either leak or poor compaction). Pipe debris previous noted on WS has been removed. (O. Magana - DWR UCIP)06/11/2013 Signs of leak in pipe at levee slope on both LS and WS where pipe enters levee. Moist soil at LS toe indicates possible internal leak. Evidence of recent pipe repair on WS. Pipe debris on WS toe should be removed. (W. Wylie - DWR UCIP) FIELD_STRUCT_DESC: 12-inch steel irrigation pipe through the levee, 5 feet below the crown. Slant pump located on the waterside (WS). Siphon breaker and switch box also located on the WS slope. Service pole is located on the landside (LS) slope. (12-inch pipe authorized under Automatic Board Order (ABO) issued as Permit No. 11203, 1971 - Delta Farmers, Inc.) This crossing has been replaced with 6-inch under DSID 25486, as reported by DWR inspector Richard Willoughby during his Spring 2017 inspection. [Additional Reference(s): DWR Levee Log, 2005. USACE Sacramento O&M Manual Unit 103, June 1954 (HLM 0.73)]

View of LS slope.

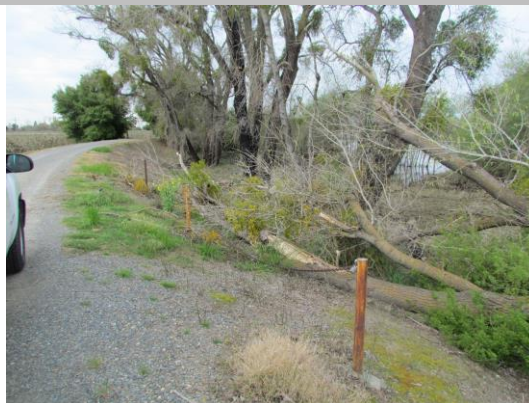
Photo 1 of 1 : SP_2018_RD0563_210_120_20180305_00099.jpg

LM Start	0.88	Rating **	M	Issue No.	120
LM End	0.88	Issue Type +	Ma	Location *	WS
Category	Earthen Levee			GPS Latitude/Longitude	
				Start	End
Item	Encroachments			38.225482 °	38.225482 °
				-121.526882 °	-121.526882 °
DWR ID	DWR_RD0563_01_s_2017_120				
Comment Code					
TR : Tree or limb					
Inspector Comment					
Fallen tree on waterward slope.

Looking southwest at fallen tree on waterward slope.

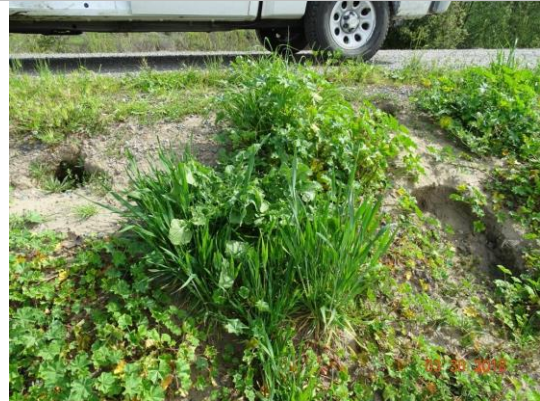
Photo 2 of 2 : SP_2018_RD0563_210_121_20180330_00239.jpg

LM Start	0.95	Rating **	U	Issue No.	121 (cont)
LM End	0.95	Issue Type +	Ma	Location *	LS
Category	Earthen Levee			GPS Latitude/Longitude	
				Start	End
Item	Animal Control			38.225808 °	38.225808 °
				-121.528197 °	-121.528197 °
DWR ID	DWR_RD0563_01_s_2017_121				
Comment Code					
A1 : Exterminate rodents and backfill and compact or grout burrows.					
Inspector Comment					
Several large rodent holes on landward slope.

3/30/2018: Rodent burrows on landside.

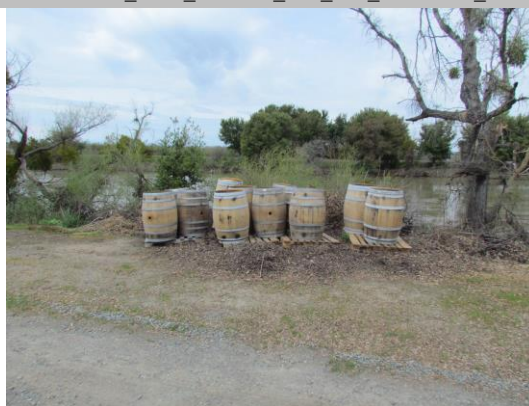
Photo 2 of 2 : SP_2018_RD0563_210_122_20180305_00102.jpg

LM Start	1.18	Rating **	M	Issue No.	122 (cont)	
LM End	1.18	Issue Type +	En	Location *	WS	
Category	Earthen Levee			GPS Latitude/Longitude		
				Start		End
Item	Encroachments			38.226737 °		38.226737 °
				-121.531747 °		-121.531747 °
DWR ID	DWR_RD0563_01_s_2017_122					
Comment Code						
GA : Garbage						
Inspector Comment						
Landowner storing prunings on waterside slope.

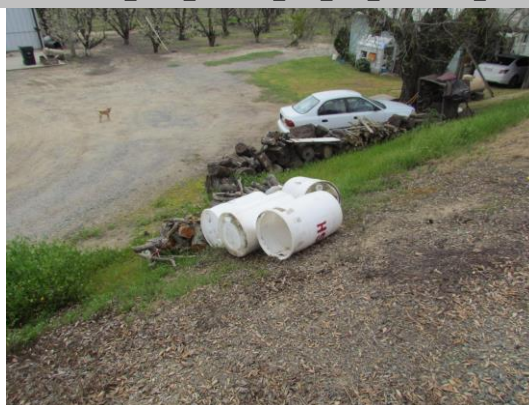
Photo 1 of 2 : SP_2018_RD0563_210_134_20180305_00111.jpg

LM Start	1.21	Rating **	M	Issue No.	134
LM End	1.21	Issue Type +	En	Location *	LS
Category	Earthen Levee			GPS Latitude/Longitude	
				Start	End
Item	Encroachments			38.226462 °	38.226462 °
				-121.532172 °	-121.532172 °
DWR ID	DWR_RD0563_01_s_2016_134				
Comment Code					
FW : Firewood					
Inspector Comment					
Landowner stock piling firewood and other garbage at landward toe.

Looking east at firewood and empty containers on landward slope. (Spring 2017)

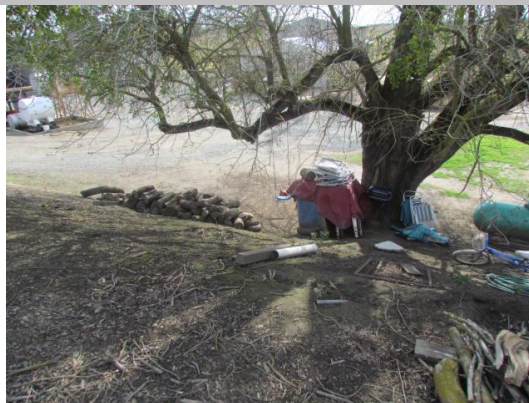
Photo 1 of 2 : SP_2018_RD0563_210_57_20180305_00041.jpg

LM Start	1.22	Rating **	U	Issue No.	57
LM End	1.22	Issue Type +	En	Location *	LS
Category	Earthen Levee			GPS Latitude/Longitude	
				Start	End
Item	Encroachments			38.226345 °	38.226345 °
				-121.532332 °	-121.532332 °
DWR ID	DWR_RD0563_01_s_2012_57				
Comment Code					
BU : Building					
Inspector Comment					
Landowner has built a shed extending from the home onto the levee toe. This unpermitted construction should be removed.

Looking east at firewood and other materials stored on landside slope and toe.

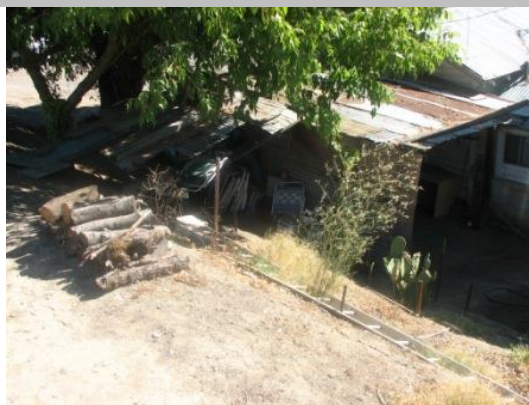
Photo 2 of 2 : SP_2018_RD0563_210_57_20180305_00042.jpg

Looking at a shed at landside toe.

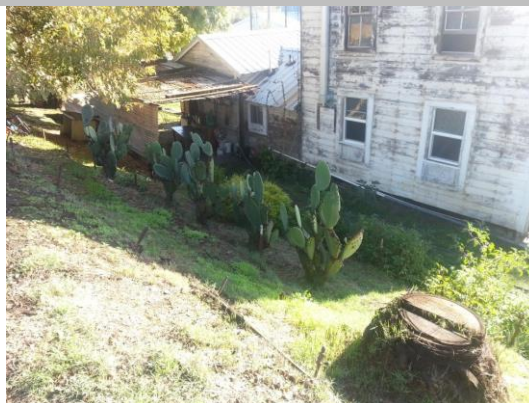
Photo 1 of 2 : SP_2018_RD0563_210_170_20180305_00132.jpg

LM Start	1.22	Rating **	M	Issue No.	170
LM End	1.24	Issue Type +	En	Location *	LS
Category	Earthen Levee			GPS Latitude/Longitude	
				Start	End
Item	Vegetation			38.226316 °	38.226053 °
				-121.532342 °	-121.532525 °
DWR ID	DWR_RD0563_01_f_2016_170				
Comment Code					
V6 : Landscaping					
Inspector Comment					
Remove cactus on landward slope.

Looking southeast at cactus on landward slope.

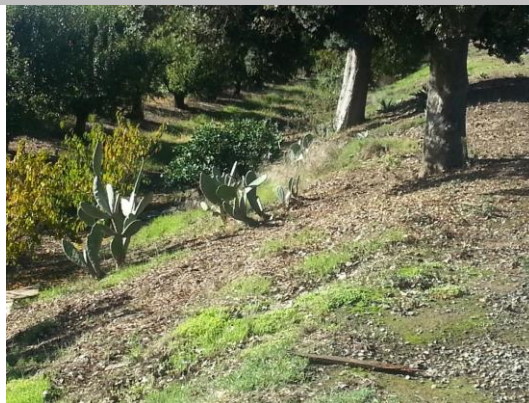
Photo 2 of 2 : SP_2018_RD0563_210_170_20180305_00133.jpg

LM Start	1.22	Rating **	M	Issue No.	170 (cont)	
LM End	1.24	Issue Type +	En	Location *	LS	
Category	Earthen Levee			GPS Latitude/Longitude		
				Start		End
Item	Vegetation			38.226316 °		38.226053 °
				-121.532342 °		-121.532525 °
DWR ID	DWR_RD0563_01_f_2016_170					
Comment Code						
V6 : Landscaping						
Inspector Comment						
Remove cactus on landward slope.

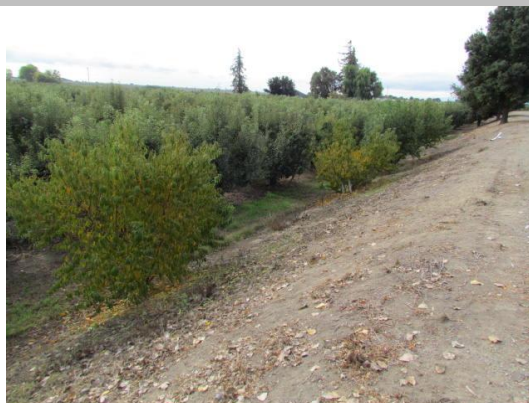
Photo 1 of 1 : SP_2018_RD0563_210_64_20180305_00044.jpg

LM Start	1.27	Rating **	M	Issue No.	64
LM End	1.27	Issue Type +	Ma	Location *	LS
Category	Earthen Levee			GPS Latitude/Longitude	
				Start	End
Item	Trim / Thin Trees			38.225730 °	38.225730 °
				-121.532824 °	-121.532824 °
DWR ID	DWR_RD0563_01_f_2012_64				
Comment Code					
T1 : Trim trees to at least five feet above ground level.					
Inspector Comment					
Fruit trees located at landside toe should be removed.

Looking southeast at fruit trees on landside toe.

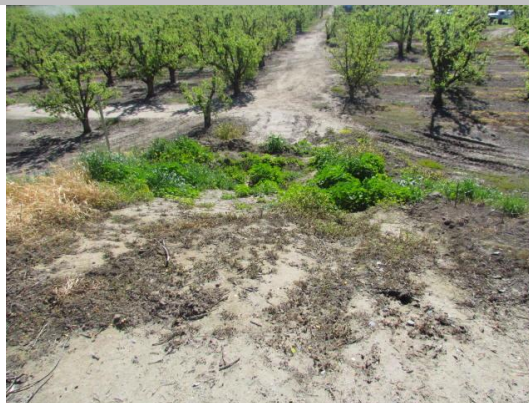
Photo 1 of 3 : SP_2018_RD0563_210_150_20180305_00123.jpg

LM Start	1.35	Rating **	M	Issue No.	150
LM End	1.35	Issue Type +	En	Location *	LS
Category	Earthen Levee			GPS Latitude/Longitude	
				Start	End
Item	Encroachments			38.224817 °	38.224817 °
				-121.533602 °	-121.533602 °
DWR ID	DWR_RD0563_01_s_2016_150				
Comment Code					
RA : Ramp					
Inspector Comment					
Unauthorized ramp on landside slope.

Looking southeast at ramp on landward slope.

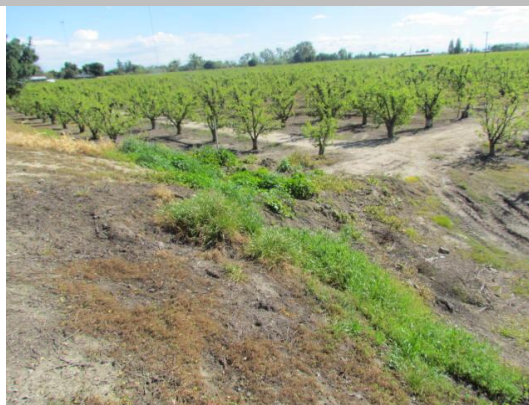
Photo 2 of 3 : SP_2018_RD0563_210_150_20180305_00124.jpg

LM Start	1.35	Rating **	M	Issue No.	150 (cont)
LM End	1.35	Issue Type +	En	Location *	LS

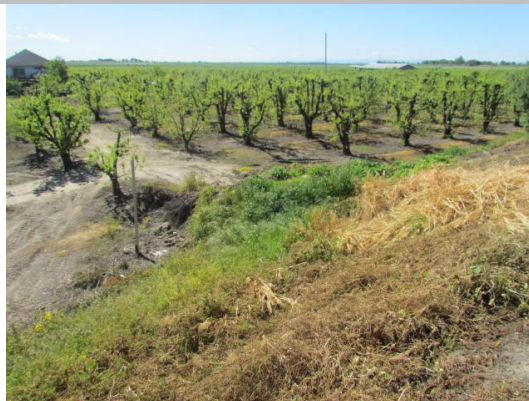
Photo 3 of 3 : SP_2018_RD0563_210_150_20180305_00125.jpg

LM Start	1.35	Rating **	M	Issue No.	150 (cont)
LM End	1.35	Issue Type +	En	Location *	LS

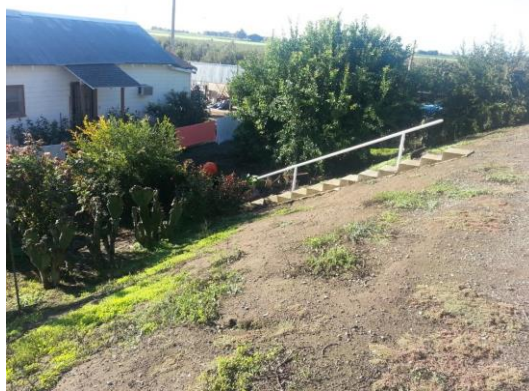
Photo 1 of 1 : SP_2018_RD0563_210_86_20180305_00073.jpg

LM Start	1.39	Rating **	U	Issue No.	86
LM End	1.39	Issue Type +	En	Location *	LS
Category	Earthen Levee			GPS Latitude/Longitude	
				Start	End
Item	Vegetation			38.224351 °	38.224351 °
				-121.534209 °	-121.534209 °
DWR ID	DWR_RD0563_01_f_2013_86				
Comment Code					
V6 : Landscaping					
Inspector Comment					
Landowner has fruit trees and other vegetation on landside slope and toe.

Looking southwest at fruit trees and other plantings at landward toe.

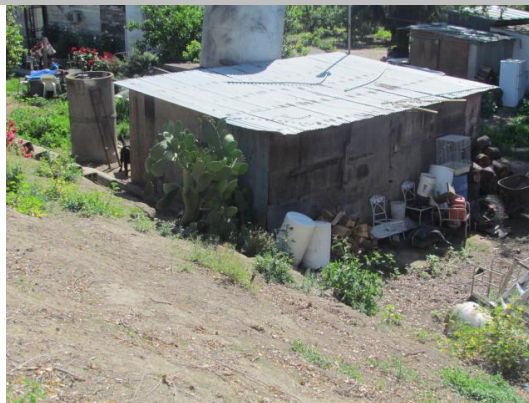
Photo 2 of 3 : SP_2018_RD0563_210_8_20180305_00005.jpg

Looking northeast at a tool shed on the landward toe.

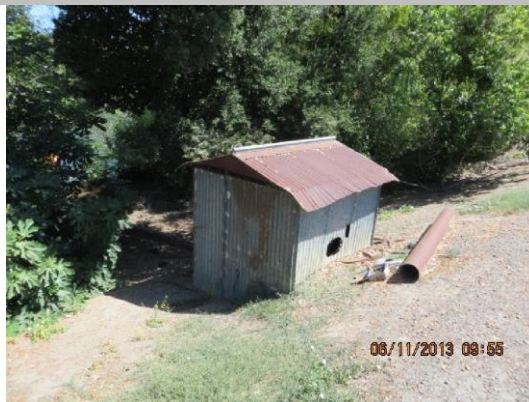
Photo 2 of 2 : UCIP_SP_2018_14873_24526.jpg

Pipe goes to pumphouse on WS slope.

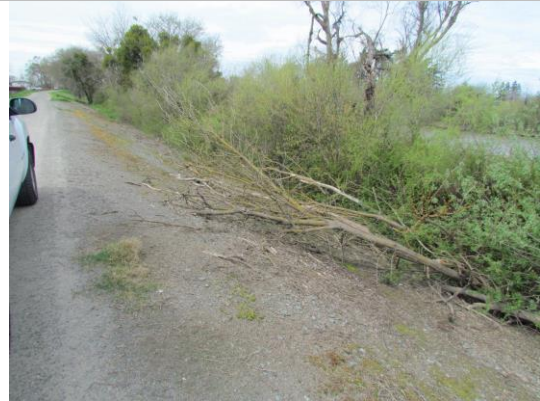
Photo 1 of 1 : SP_2018_RD0563_210_123_20180305_00103.jpg

LM Start	1.69	Rating **	M	Issue No.	123
LM End	1.69	Issue Type +	Ma	Location *	WS
Category	Earthen Levee			GPS Latitude/Longitude	
				Start	End
Item	Encroachments			38.223110 °	38.223110 °
				-121.539495 °	-121.539495 °
DWR ID	DWR_RD0563_01_s_2017_123				
Comment Code					
TR : Tree or limb					
Inspector Comment					
Fallen tree on waterside slope.

Looking south at fallen tree on waterward slope.

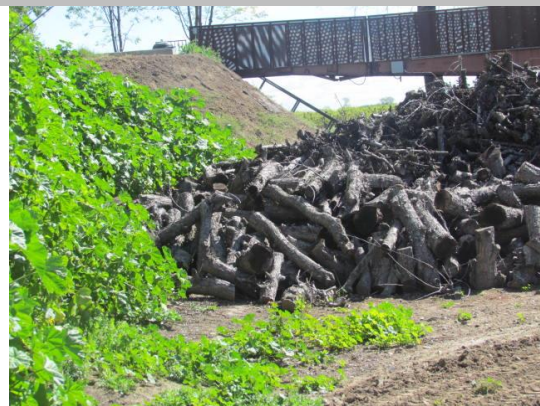
Photo 1 of 1 : SP_2018_RD0563_210_161_20180305_00129.jpg

LM Start	1.82	Rating **	M	Issue No.	161
LM End	1.82	Issue Type +	En	Location *	LS
Category	Earthen Levee			GPS Latitude/Longitude	
				Start	End
Item	Encroachments			38.222768 °	38.222768 °
				-121.541837 °	-121.541837 °
DWR ID	DWR_RD0563_01_s_2016_161				
Comment Code					
FW : Firewood					
Inspector Comment					
Landowner stocking firewood at landside toe.

Looking north at firewood at landward toe.

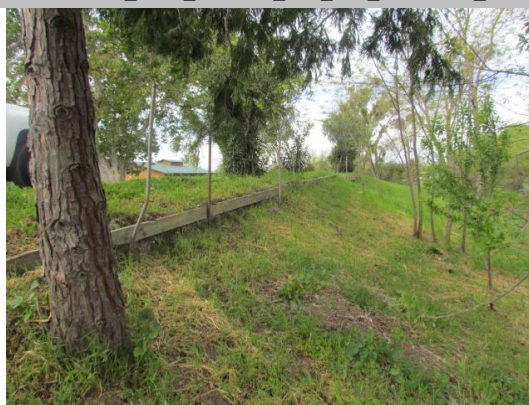
Photo 3 of 4 : SP_2018_RD0563_210_142_20180305_00118.jpg

Looking southeast at planting box on waterward shoulder.

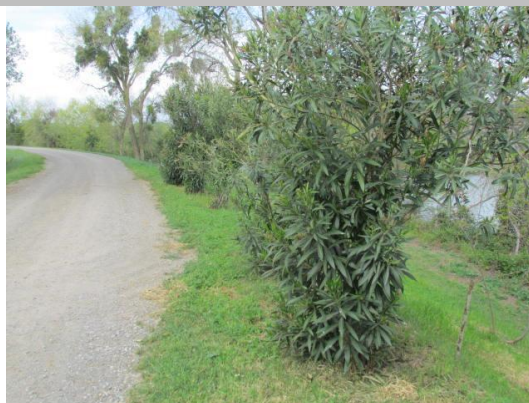
Photo 4 of 4 : SP_2018_RD0563_210_142_20180305_00119.jpg

Looking southwest at oleanders on waterward shoulder.

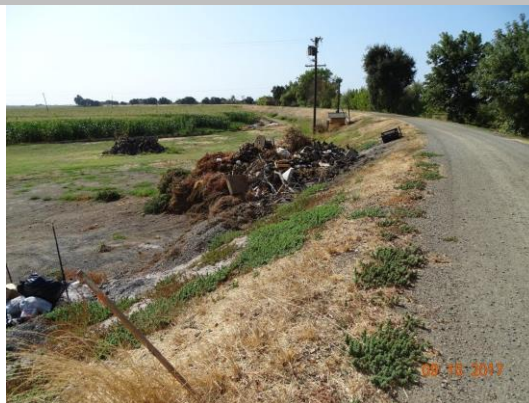
Photo 1 of 1 : SP_2018_RD0563_210_157_20180305_00128.jpg

LM Start	1.94	Rating **	U	Issue No.	157
LM End	1.94	Issue Type +	En	Location *	LS
Category	Earthen Levee			GPS Latitude/Longitude	
				Start	End
Item	Encroachments			38.222080 °	38.222080 °
				-121.543445 °	-121.543445 °
DWR ID	DWR_RD0563_01_f_2015_157				
Comment Code					
GA : Garbage					
Inspector Comment					
Landowner stockpiling garbage at landside toe.

Looking south at the garbage on the landside toe.

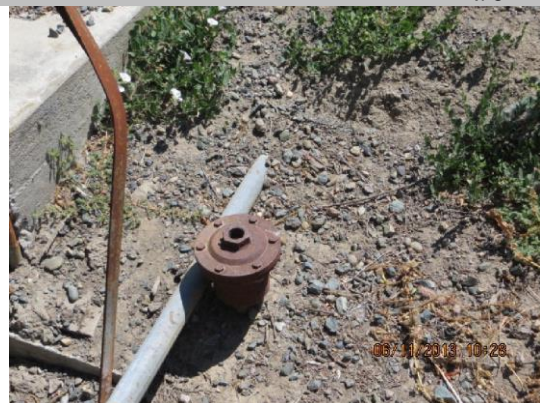
Photo 2 of 3 : UCIP_SP_2018_51449_24536.jpg

FS_ID:51449
DS_ID:20136
EP_NO: 11204
Repair Type: Non-Urgent
Crossing Status: Found
UCIP Comments: 12/02/2016 same as last inspection. Crossing has been downgraded from "Urgent" to "Non-Urgent" no signs of leaks were visible from the surface. Owner will need to coordinate with the CVFPB to comply with Title 23 regarding the sleeved pipe and the non-annular space between the larger and smaller pipe. (O. Magana - DWR UCIP)06/11/2013 Annular space not grouted between 8-inch and 10-inch pipe and the metal walkway is structurally failing. (W. Wylie - DWR UCIP)
FIELD_STRUCT_DESC: 8-inch steel irrigation pipe sleeved through a 10-inch pipe (12-inch referenced in permit recordation) through the levee, 4 feet below the crown. 1.5-inch electrical conduit of an unknown material through the levee at the same location, at an unknown depth. Pump on pile structure on the waterside (WS). Timber walkway to pump on the WS. Service pole on the landside (LS) slope. Siphon breaker on the WS slope (12-inch pipe owner name change issued under Permit No. 11204-1, 2015 - Jim Morris. 12-inch pipe [HLM 1.99] authorized under Automatic Board Order (ABO) issued as Permit No. 11204, 1975 - Jim Morris). [Additional Reference(s): DWR Levee Log, 2005. USACE Sacramento O&M Manual 103, June 1954, (Station ""L"" 119+16), listed as a 16-inch pipe].

Siphon breaker and 1.5-inch galvanized iron electrical conduit.

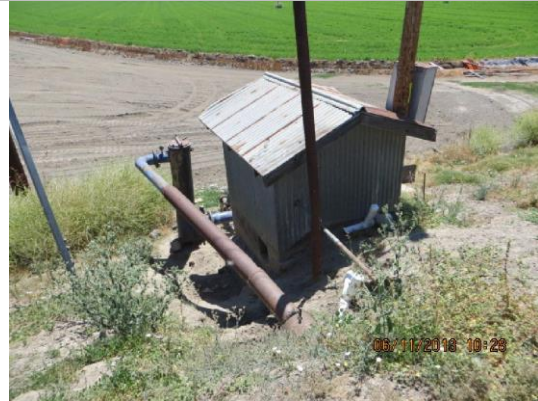
Photo 3 of 3 : UCIP_SP_2018_51449_24535.jpg

Comment Code						
Inspector Comment						
FS_ID:51449 DS_ID:20136 EP_NO: 11204 Repair Type: Non-Urgent Crossing Status: Found UCIP Comments: 12/02/2016 same as last inspection. Crossing has been downgraded from "Urgent" to "Non-Urgent" no signs of leaks were visible from the surface. Owner will need to coordinate with the CVFPB to comply with Title 23 regarding the sleeved pipe and the non-annular space between the larger and smaller pipe. (O. Magana - DWR UCIP)06/11/2013 Annular space not grouted between 8-inch and 10-inch pipe and the metal walkway is structurally failing. (W. Wylie - DWR UCIP) FIELD_STRUCT_DESC: 8-inch steel irrigation pipe sleeved through a 10-inch pipe (12-inch referenced in permit recordation) through the levee, 4 feet below the crown. 1.5-inch electrical conduit of an unknown material through the levee at the same location, at an unknown depth. Pump on pile structure on the waterside (WS). Timber walkway to pump on the WS. Service pole on the landside (LS) slope. Siphon breaker on the WS slope (12-inch pipe owner name change issued under Permit No. 11204-1, 2015 - Jim Morris. 12-inch pipe [HLM 1.99] authorized under Automatic Board Order (ABO) issued as Permit No. 11204, 1975 - Jim Morris). [Additional Reference(s): DWR Levee Log, 2005. USACE Sacramento O&M Manual 103, June 1954, (Station ""L"" 119+16), listed as a 16-inch pipe]. FS Date: 12/2/2016

Pipe at outlet on LS toe.

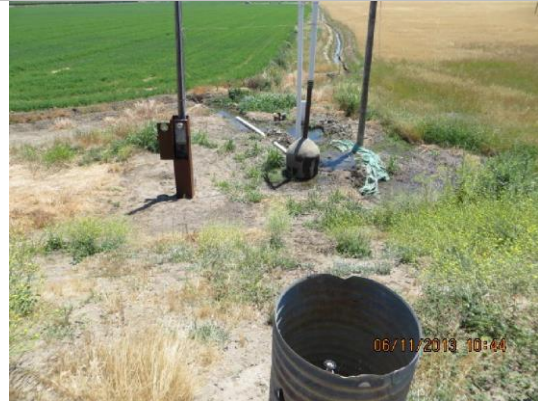
Photo 2 of 3 : UCIP_SP_2018_51450_24540.jpg

FS_ID:51450
DS_ID:20176
EP_NO: 13311
Repair Type: Urgent
Crossing Status: Found
UCIP Comments: 12/02/2016 Dense vegetation around concrete standpipe located on LS toe assume issue recorded back in 2013 is still present due to the dense vegetation around structure. Need to contact owner. Owner will need to coordinate with the CVFPB to address the leaky concrete standpipe and the new metal case installed on WS slope (section of levee still opened). (O. Magana - DWR UCIP)06/11/2013 Concrete standpipe on LS toe is not functioning properly. Leaks springing up in the ground around the standpipe. This may erode the soil at base of levee. (W. Wylie - DWR UCIP)
FIELD_STRUCT_DESC: 1 of 2: 12-inch steel irrigation pipe through levee, 3 feet below the crown. Slant pump is located on the waterside (WS) toe. 36-inch concrete standpipe and pipe works visible on the landside (LS) toe. Siphon breaker in 24-inch corrugated metal pipe (CMP) riser located on the LS shoulder. Pipe replaced 12-inch pipe from O&M manual/Permit No. 11207. (Permit No. 13311, 1982). (12-inch replaced under Permit No. 13311, 1981 - P. L. Lykins Ranch; 12-inch pipe authorized under Automatic Board Order (ABO) issued as Permit No. 11207, 1975 - Fong)

Concrete standpipe, and 24-inch CMP riser on LS of levee.

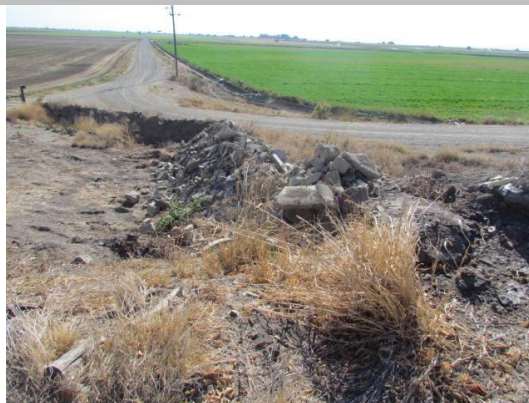
Photo 2 of 2 : SP_2018_RD0563_210_104_20180305_00090.jpg

LM Start	2.89	Rating **	M	Issue No.	104
LM End	2.89	Issue Type +	En	Location *	LS
Category	Earthen Levee			GPS Latitude/Longitude	
				Start	End
Item	Encroachments			38.210966 °	38.210966 °
				-121.534813 °	-121.534813 °
DWR ID	DWR_RD0563_01_f_2013_104				
Comment Code					
MA : Material					
Inspector Comment					
Landowner stockpiled concrete rubble on landward and waterward slope to stop trespassers. Landowner should replace the stockpile with a proper fence.

Looking east at concrete rubble on landward slope.

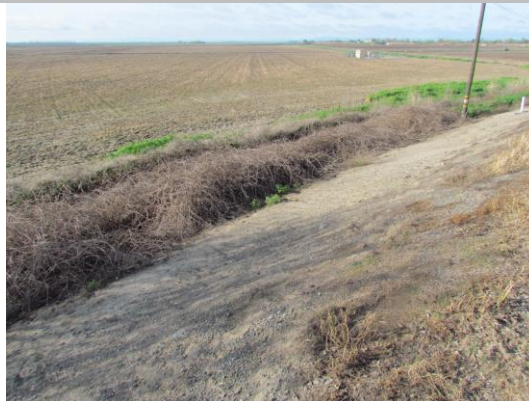
Photo 1 of 2 : SP_2018_RD0563_210_67_20180305_00046.jpg

Looking east at dead berryvines at landward toe. (Spring 2017)

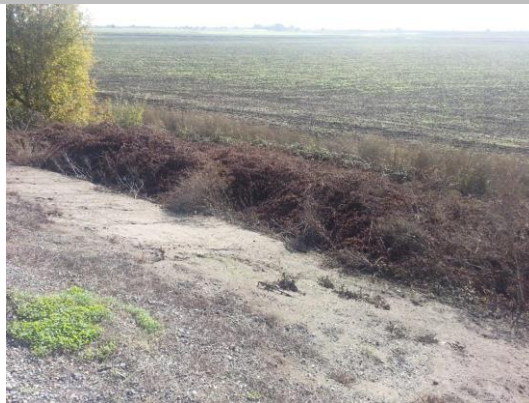
Photo 2 of 2 : SP_2018_RD0563_210_67_20180305_00047.jpg

Looking east at dead berryvines at landward toe. (Fall 2016)

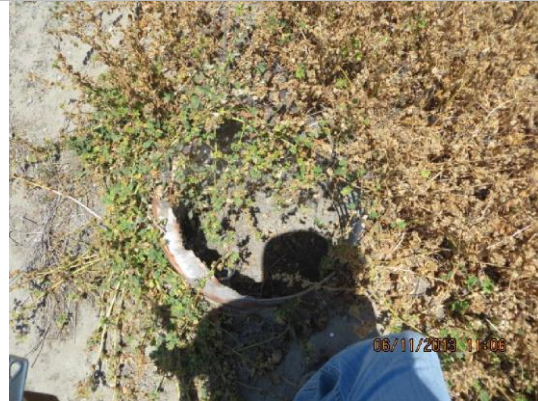
Photo 1 of 1 : UCIP_SP_2018_14885_24548.jpg

LM Start	3.00	Rating **	M	Issue No.	781
LM End	3.00	Issue Type +	En	Location *	
Category	Supplemental			GPS Latitude/Longitude	
				Start	End
Item	DWR UCIP Field Study			38.210209 °	38.210209 °
				-121.536313 °	-121.536313 °
DWR ID					
Comment Code					
Inspector Comment					
FS_ID:14885 DS_ID:20139 EP_NO: N/A Repair Type: Non-Urgent Crossing Status: Found UCIP Comments: Abandoned and should be done so properly. Need to verify disposition of pipe. FIELD_STRUCT_DESC: *ABANDONED* 6-inch steel pipe of an unknown purpose through the levee, 4 feet below the crown. Siphon breaker in a 24-inch corrugated metal pipe (CMP) riser on the landside (LS) shoulder. Open on both ends. [Additional Reference(s): DWR Levee Log, 2005. USACE Sacramento O&M Manual 103, June 1954, (Station ""L2"" 62+79) 1-inch air valve, brass cock and cover]. FS Date: 6/11/2013

24-inch CMP standpipe on LS slope.

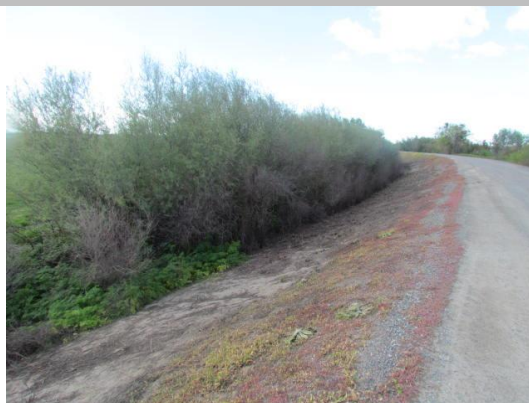
Photo 3 of 5 : SP_2018_RD0563_210_74_20180305_00057.jpg

Looking south at dense vegetation (willows) at landward toe. (Spring 2016)

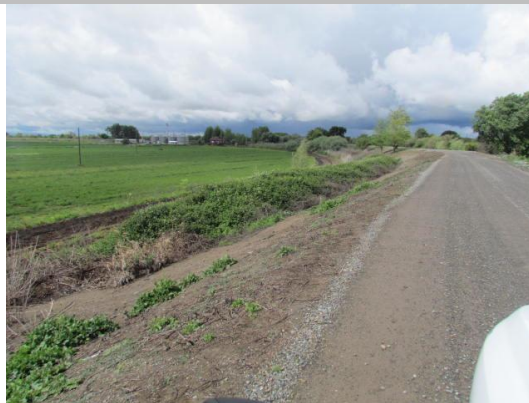
Photo 4 of 5 : SP_2018_RD0563_210_74_20180305_00058.jpg

Looking southeast at dense berryvines at landward toe. (Spring 2015)

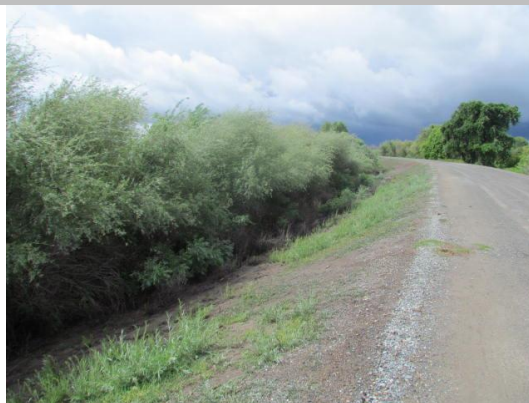
Photo 5 of 5 : SP_2018_RD0563_210_74_20180305_00059.jpg

LM Start	3.02	Rating **	M	Issue No.	74 (cont)	
LM End	3.21	Issue Type +	Ma	Location *	LS	
Category	Earthen Levee			GPS Latitude/Longitude		
				Start		End
Item	Vegetation			38.210212 °		38.209165 °
				-121.536728 °		-121.539920 °
DWR ID	DWR_RD0563_01_s_2012_74					
Comment Code						
V2 : Remove the wild growth other than native grasses from the levee slopes.						
Inspector Comment						
Dead berryvines and dense vegetation at landside toe blocking view of toe.

Looking south at dense vegetation at landward slope and toe. (Spring 2015)

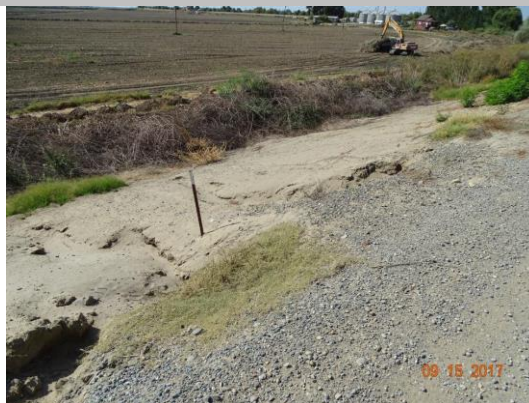
Photo 1 of 5 : SP_2018_RD0563_210_78_20180305_00065.jpg

LM Start	3.06	Rating **	U	Issue No.	78
LM End	3.06	Issue Type +	Ma	Location *	LS
Category	Earthen Levee			GPS Latitude/Longitude	
				Start	End
Item	Slope Stability			38.210240 °	38.210240 °
				-121.537517 °	-121.537517 °
DWR ID	DWR_RD0563_01_s_2012_78				
Comment Code					
S1 : Repair slope instability.					
Inspector Comment					
Slope damage on landside shoulder and slope has been in place for several inspection cycles. Proper drainage should be provided to prevent further erosion, and erosion should be repaired.

Looking southwest at the landside slope.

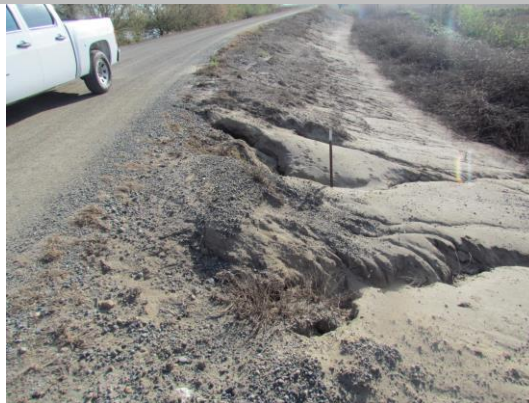
Photo 2 of 5 : SP_2018_RD0563_210_78_20180305_00066.jpg

Looking north at rain runoff erosion on landward slope. (Spring 2017)

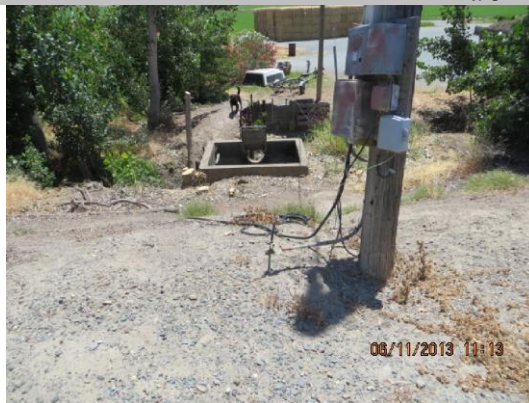
Photo 1 of 2 : UCIP_SP_2018_14887_24550.jpg

Comment Code						
Inspector Comment						
FS_ID:14887 DS_ID:20140 EP_NO: 12708 Repair Type: Non-Urgent Crossing Status: Found UCIP Comments: Pipe heavily corroded. Good candidate for viewo inspection. FIELD_STRUCT_DESC: 1 of 2: 14-inch coated steel irrigation pipe through the levee, 3 feet below the crown. Slant pump and gate valve on the waterside (WS). 9-foot by 7-foot reinforced concrete distribution box on the landside (LS) toe. Service pole on the LS shoulder. (Permit No. 12708, 1979 - George C. Wilson, replaced 8-inch pipe under Permit No. 11211, 1975 - Erma E. Locke). [Additional Reference(s): DWR Levee Log, 2005. USACE Sacramento O&M Manual 103, June 1954]. FS Date: 6/11/2013

Distribution box and JP on LS.

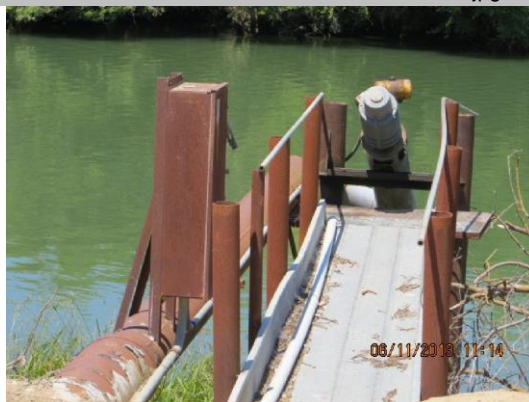
Photo 2 of 2 : UCIP_SP_2018_14887_24549.jpg

Pump and walkway on WS.

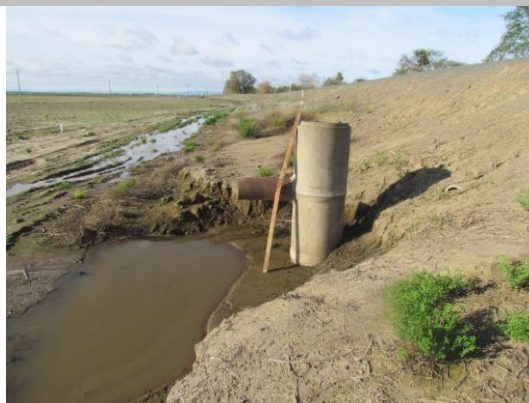
Photo 1 of 4 : SP_2018_RD0563_210_125_20180305_00104.jpg

LM Start	3.90	Rating **	M	Issue No.	125
LM End	4.24	Issue Type +	En	Location *	LS
Category	Earthen Levee			GPS Latitude/Longitude	
				Start	End
Item	Encroachments			38.200627 °	38.197060 °
				-121.542282 °	-121.546190 °
DWR ID	DWR_RD0563_01_s_2017_125				
Comment Code					
AT : Agricultural tilling					
Inspector Comment					
Six to twelve inch cut along the landside toe.

Looking at erosion around stand pipe at landward toe.

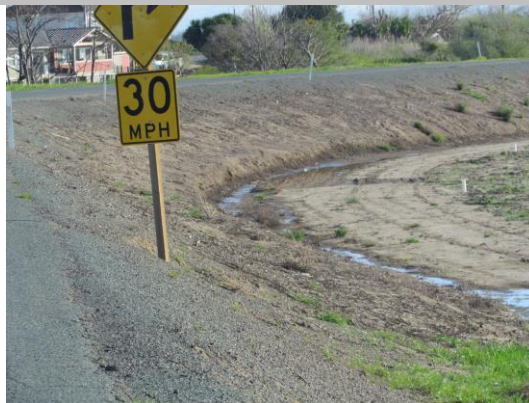
Photo 2 of 4 : SP_2018_RD0563_210_125_20180305_00105.jpg

Looking west at cut along farm's service road at landward toe and berm.

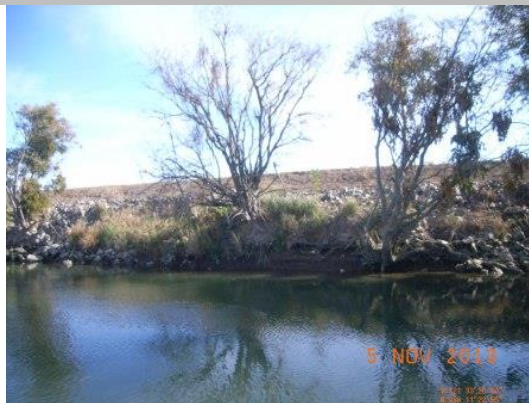
Photo 1 of 1 : SP_2018_RD0563_210_38_20180305_00026.jpg

LM Start	3.91	Rating **	M	Issue No.	38
LM End	4.01	Issue Type +	Ma	Location *	WS
Category	Supplemental			GPS Latitude/Longitude	
				Start	End
Item	2015 USACE Erosion Survey, DRAFT			38.200733 °	38.199925 °
				-121.542571 °	-121.544249 °
DWR ID	DWR_RD0563_01_s_2016_38				
Comment Code					
Inspector Comment					
1997 - Narrow eroding berm upstream of existing rock. 2001 - Staked, low fascine walls at bankline. 2011 - Minor new erosion. Site extended downstream. 2012 - Rock repair failing in one erosion pocket. 2015: Last observed in 2013. [2015 Site ID: GEO_8-3_L]

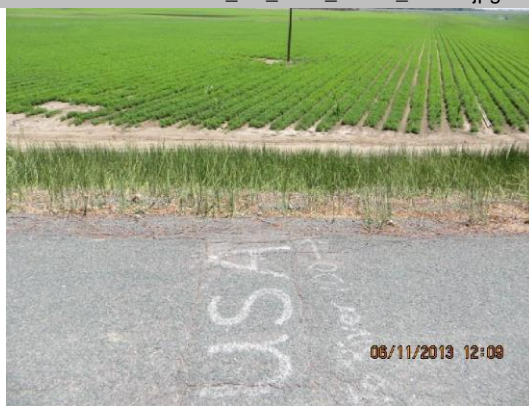
Photo 2 of 3 : UCIP_SP_2018_16244_27389.jpg

LM Start	4.26	Rating **	M	Issue No.	784 (cont)	
LM End	4.26	Issue Type +	En	Location *		
Category	Supplemental			GPS Latitude/Longitude		
				Start	End	
Item	DWR UCIP Field Study			38.196725 °	38.196725 °	
				-121.546310 °	-121.546310 °	
DWR ID						
Comment Code						
Inspector Comment						
FS_ID:16244 DS_ID:23971 EP_NO: N/A Repair Type: Non-Urgent Crossing Status: Found UCIP Comments: Need to determine disposition of pipe. Likely that this pipe was removed from levee section as evidenced by the cut in pavement on crown. FIELD_STRUCT_DESC: 4.5-inch gas line of an unknown material through the levee, at an unknown depth. Cut in pavement and pipe visible on the waterside (WS) toe. (Permit No. 15539 - Pacific Gas and Electric Company [PG&E] [date not indicated in permit]). FS Date: 6/11/2013

Cut in pavement with USAA markings for gasline.

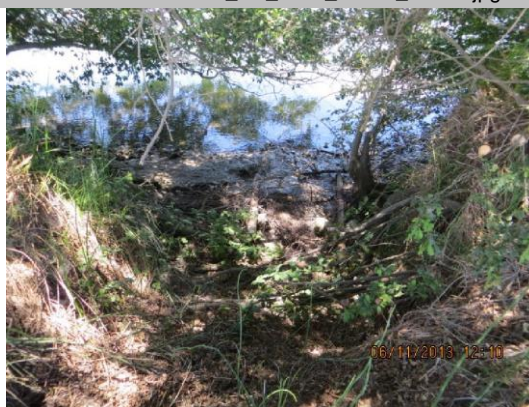
Photo 3 of 3 : UCIP_SP_2018_16244_27388.jpg

Pipe visible on WS toe.

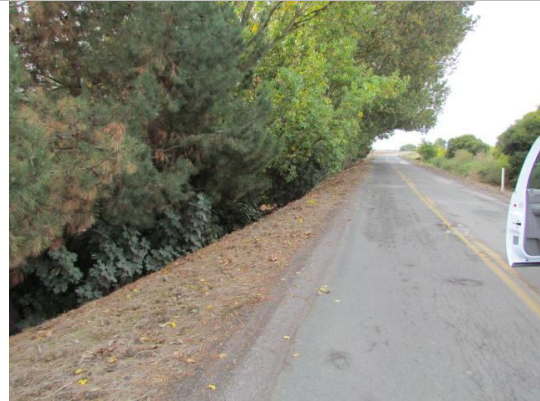
Photo 1 of 1 : SP_2018_RD0563_210_88_20180305_00074.jpg

LM Start	4.63	Rating **	M	Issue No.	88
LM End	4.64	Issue Type +	En	Location *	LS
Category	Earthen Levee			GPS Latitude/Longitude	
				Start	End
Item	Vegetation			38.193078 °	38.192980 °
				-121.551047 °	-121.551263 °
DWR ID	DWR_RD0563_01_s_2012_88				
Comment Code					
V6 : Landscaping					
Inspector Comment					
Fig tree and pine trees block view of landside slope.

Looking south at dense trees on landside slope and toe.

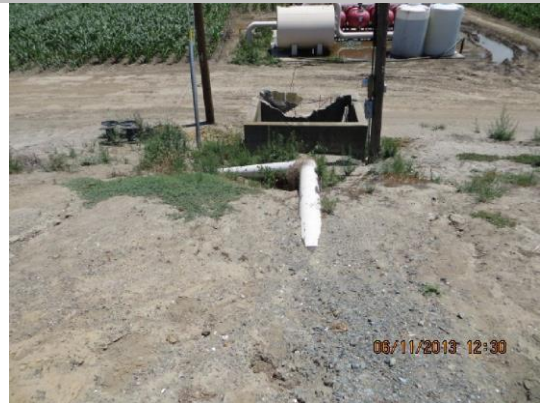
Photo 1 of 3 : UCIP_SP_2018_14927_24590.jpg

Comment Code					
Inspector Comment					
FS_ID:14927 DS_ID:20145 EP_NO: 11205 Repair Type: Non-Urgent Crossing Status: Found UCIP Comments: Some settlement over pipe on WS shoulder and there is some animal burrow tunnels over the pipe on the LS shoulder. FIELD_STRUCT_DESC: 4 of 5: 10-inch steel irrigation pipe through the levee, 3.8 feet below the crown. Siphon breaker on the landside (LS) shoulder. Slant pump off the waterside (WS) toe. Booster and filter station off the LS toe. Abandoned concrete distribution box at the LS toe. 1-inch galvanized iron electrical conduit through the levee at the same location, at an unknown depth. (Automatic Board Order (ABO) issued as Permit No. 11205, 1975 - Joshua Eppinger Jr.). [Additional Reference(s): DWR Levee Log, 2005. USACE Sacramento O&M Manual 103, June 1954, (Station ""L"" 390+74.5)]. FS Date: 6/11/2013

Pipe, distribution box, JP, electrical conduit, and booster/filter system on LS.

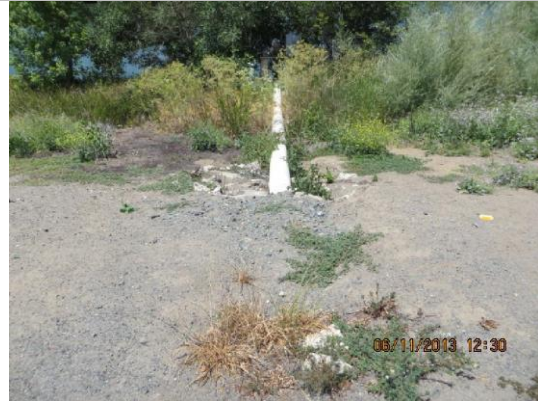
Photo 2 of 3 : UCIP_SP_2018_14927_24589.jpg

Comment Code						
Inspector Comment						
FS_ID:14927 DS_ID:20145 EP_NO: 11205 Repair Type: Non-Urgent Crossing Status: Found UCIP Comments: Some settlement over pipe on WS shoulder and there is some animal burrow tunnels over the pipe on the LS shoulder. FIELD_STRUCT_DESC: 4 of 5: 10-inch steel irrigation pipe through the levee, 3.8 feet below the crown. Siphon breaker on the landside (LS) shoulder. Slant pump off the waterside (WS) toe. Booster and filter station off the LS toe. Abandoned concrete distribution box at the LS toe. 1-inch galvanized iron electrical conduit through the levee at the same location, at an unknown depth. (Automatic Board Order (ABO) issued as Permit No. 11205, 1975 - Joshua Eppinger Jr.). [Additional Reference(s): DWR Levee Log, 2005. USACE Sacramento O&M Manual 103, June 1954, (Station ""L"" 390+74.5)]. FS Date: 6/11/2013

Pipe on WS slope.

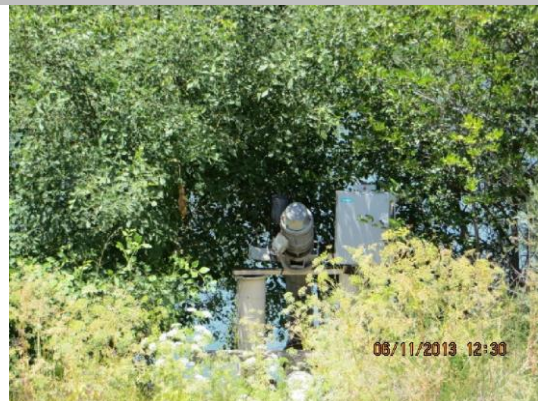
Photo 3 of 3 : UCIP_SP_2018_14927_24588.jpg

Slant pump off WS toe.

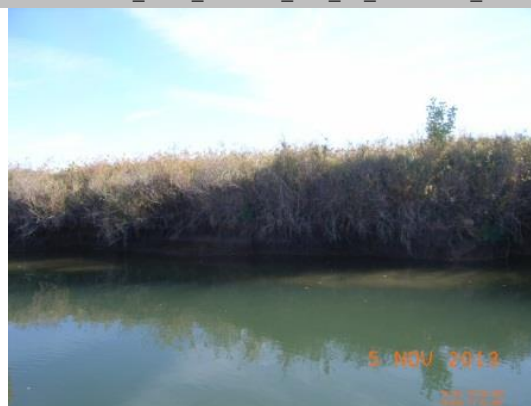
Photo 1 of 1 : SP_2018_RD0563_210_45_20180305_00033.jpg

LM Start	4.98	Rating **	M	Issue No.	45
LM End	5.04	Issue Type +	Ma	Location *	WS
Category	Supplemental			GPS Latitude/Longitude	
				Start	End
Item	2015 USACE Erosion Survey, DRAFT			38.190073 °	38.189524 °
				-121.556307 °	-121.557227 °
DWR ID	DWR_RD0563_01_s_2016_45				
Comment Code					
Inspector Comment					
2009 - Small scallops of erosion into the levee toe behind brush boxes. 2011 - Minor new erosion. 2012 - Site extended upstream to account for addition erosion pockets. 2015: Last observed in 2013. [2015 Site ID: GEO_7-2_L]

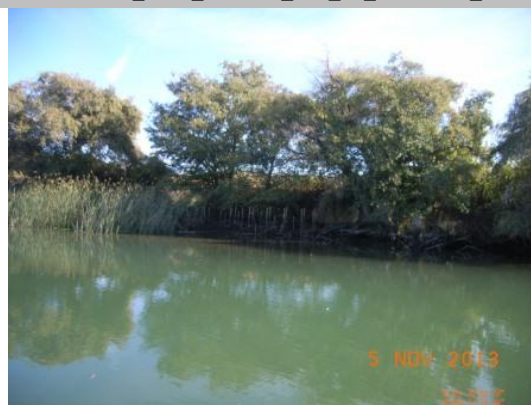
Photo 1 of 1 : SP_2018_RD0563_210_46_20180305_00034.jpg

LM Start	5.15	Rating **	U	Issue No.	46
LM End	5.39	Issue Type +	Ma	Location *	WS
Category	Supplemental			GPS Latitude/Longitude	
				Start	End
Item	2015 USACE Erosion Survey, DRAFT			38.188216 °	38.185968 °
				-121.558442 °	-121.561667 °
DWR ID	DWR_RD0563_01_s_2016_46				
Comment Code					
Inspector Comment					
1997 - Deep pockets of erosion into a narrow berm just downstream of the rock. 2000 - Scallops in banks with small colored flags, some new biotech rolls in with older rolls in the scallops. 2001 - Staked , low fascine walls at the bankline. 2011 - Site upgraded to CRITICAL. Site extended upstream due to new erosion pocket. New tree popouts and new erosion. 2013 - Pipe observed at upstream end of site. 2015: Last observed in 2013. [2015 Site ID: GEO_6-8_L]

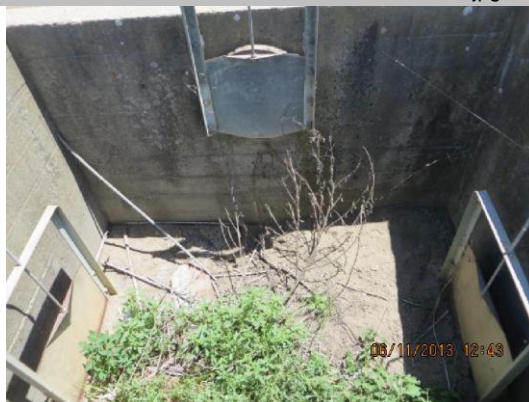
Photo 2 of 3 : UCIP_SP_2018_14943_24594.jpg

Comment Code						
Inspector Comment						
FS_ID:14943 DS_ID:20146 EP_NO: 11205 Repair Type: Non-Urgent Crossing Status: Found UCIP Comments: Need to verify wether or not pipe has been abandoned. FIELD_STRUCT_DESC: 5 of 5: 8-inch steel irrigation pipe through the levee, 3.7 feet below the crown. Pump and gate valve on the waterside (WS) end. Siphon breaker on the landside (LS) shoulder. (Automatic Board Order (ABO) issued as Permit No. 11205, 1975 - Joshua Eppinger Jr.). [Additional Reference(s): DWR Levee Log, 2005. USACE Sacramento O&M Manual 103, June 1954, (Station ""L"" 368+38) 1-inch air valve, brass cock and cover, reinforced concrete spillbox]. FS Date: 6/11/2013

Inside distribution box at LS toe.

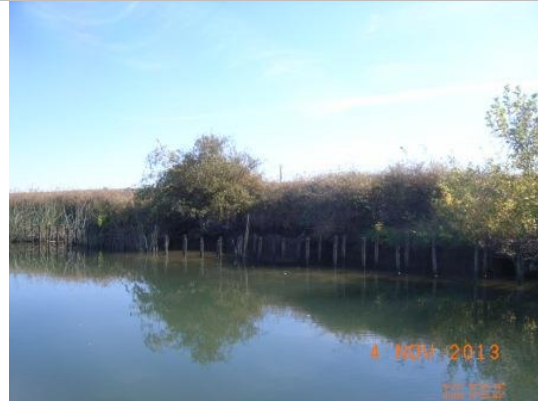
Photo 1 of 1 : SP_2018_RD0563_210_55_20180305_00040.jpg

Comment Code					
Inspector Comment					
1997 - Deep pockets of erosion and narrow berm. Reach is characterized by lots of pockets into the existing berm and/or levee slope. 1999 - Some pockets filled with rock riprap. 2000 - Exposed fabric. 2001 - Staked, low fascine walls at bankline. 2002 - New spot of rock at upstream end. Some new brush boxes. 2005 - Some stone sliding off the underlying geotextile fabric. Some new brush bundles in the brush boxes; some with missing bundles. Some boxes too low relative to high tide. 2009 - Minimal new erosion, site length extended. 2010 - New erosion on downstream end, site extended downstream. 2011 - Sites 6.1, 6.4 and 6.6 were combined. New erosion pockets, site extended to include the erosion in between the old sites. 2012 - Rock has been placed in portions of the bank since last year. 2015: Last observed in 2013. [2015 Site ID: GEO_6-3_L]

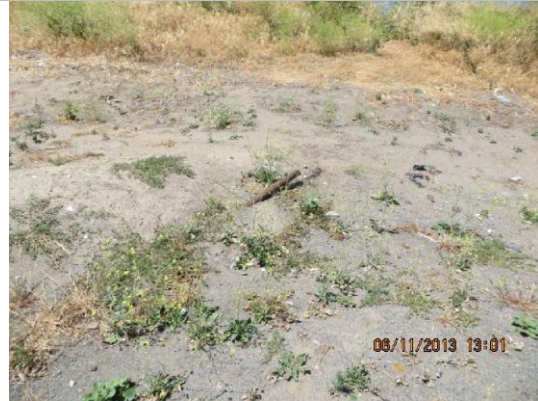
Photo 2 of 2 : UCIP_SP_2018_16289_27438.jpg

LM Start	5.87	Rating **	M	Issue No.	787 (cont)
LM End	5.87	Issue Type +	En	Location *	
Category	Supplemental			GPS Latitude/Longitude	
				Start	End
Item	DWR UCIP Field Study			38.182398 °	38.182398 °
				-121.569078 °	-121.569078 °
DWR ID					
Comment Code					
Inspector Comment					
FS_ID:16289 DS_ID:20148 EP_NO: 1826 Repair Type: Non-Urgent Crossing Status: Found UCIP Comments: Pipe abandoned and should be done so properly. FIELD_STRUCT_DESC: *ABANDONED* 2-inch discharge pipe of an unknown material through the levee, 2.7 feet below the crown. (Permit No. 1826, 1953 - Brazos Oil and Gas Company). [Additional Reference(s): DWR Levee Log, 2005]. FS Date: 6/11/2013

Pipe visible on WS shoulder.

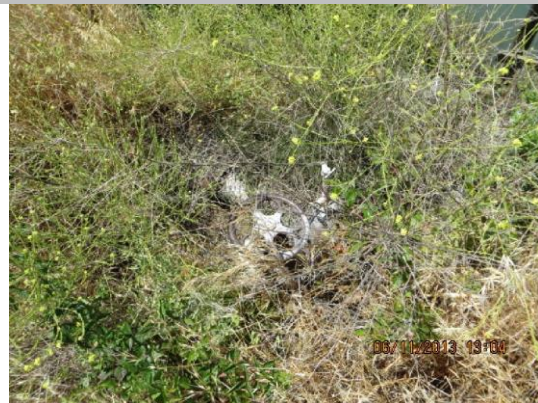
Photo 1 of 3 : UCIP_SP_2018_14949_24603.jpg

Comment Code						
Inspector Comment						
FS_ID:14949 DS_ID:20175 EP_NO: 11206 Repair Type: Non-Urgent Crossing Status: Found UCIP Comments: Pipe appears abandoned and should be done so properly. FIELD_STRUCT_DESC: 1 of 2: 8-inch steel irrigation pipe through the levee, 3.7 feet below the crown. Pump and gate valve on the waterside (WS). Siphon breaker on the landside (LS) shoulder. 7-foot by 9-foot concrete distribution box at the LS toe. (Automatic Board Order (ABO) issued as Permit No. 11206, 1975 - Daniel Faustman). [Additional Reference(s): DWR Levee Log, 2005. USACE Sacramento O&M Manual 103, June 1954, (Station ""L "" 331+00.5)]. FS Date: 6/11/2013

Slide gate at pump on WS slope

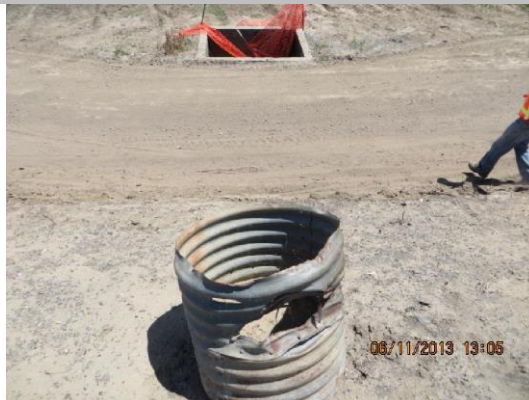
Photo 3 of 3 : UCIP_SP_2018_14949_24601.jpg

Comment Code						
Inspector Comment						
FS_ID:14949 DS_ID:20175 EP_NO: 11206 Repair Type: Non-Urgent Crossing Status: Found UCIP Comments: Pipe appears abandoned and should be done so properly. FIELD_STRUCT_DESC: 1 of 2: 8-inch steel irrigation pipe through the levee, 3.7 feet below the crown. Pump and gate valve on the waterside (WS). Siphon breaker on the landside (LS) shoulder. 7-foot by 9-foot concrete distribution box at the LS toe. (Automatic Board Order (ABO) issued as Permit No. 11206, 1975 - Daniel Faustman). [Additional Reference(s): DWR Levee Log, 2005. USACE Sacramento O&M Manual 103, June 1954, (Station ""L "" 331+00.5)]. FS Date: 6/11/2013

Siphon breaker in 24-inch CMP riser on LS shoulder.

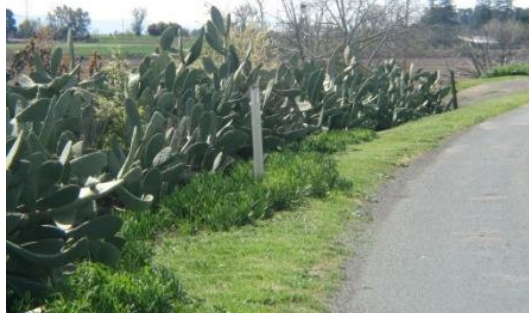
Photo 1 of 2 : SP_2018_RD0563_210_22_20180305_00013.jpg

LM Start	5.92	Rating **	U	Issue No.	22
LM End	5.96	Issue Type +	Ma	Location *	LS
Category	Earthen Levee			GPS Latitude/Longitude	
				Start	End
Item	Vegetation			38.181965 °	38.181763 °
				-121.569913 °	-121.570447 °
DWR ID	DWR_RD0563_01_s_2012_22				
Comment Code					
V2 : Remove the wild growth other than native grasses from the levee slopes.					
Inspector Comment					
Large cactus on landside slope.

Large cactus plant on landward slope from LM 6.04 to 6.08

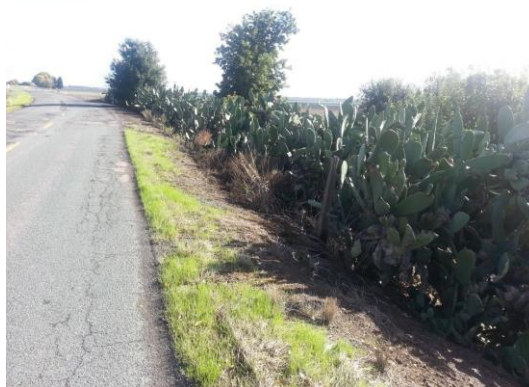
Photo 2 of 2 : SP_2018_RD0563_210_22_20180305_00014.jpg

LM Start	5.92	Rating **	U	Issue No.	22 (cont)
LM End	5.96	Issue Type +	Ma	Location *	LS

Looking downstream at dense cactus on landward slope. (Fall 2016)
